B & K LAKE NO. 2 DAM
WARREN COUNTY, MISSOURI
MO. 11002

**PHASE I INSPECTION REPORT
NATIONAL DAM SAFETY PROGRAM**

PHASE I INSPECTION REPORT
NATIONAL DAM SAFETY PROGRAM

Name of Dam: B & K Lake No. 2 Dam, Missouri Inv. No. 11002
State Located: Missouri
County Located: Warren
Stream: An Unnamed Tributary of Lost Creek
Date of Inspection: August 20, 1979

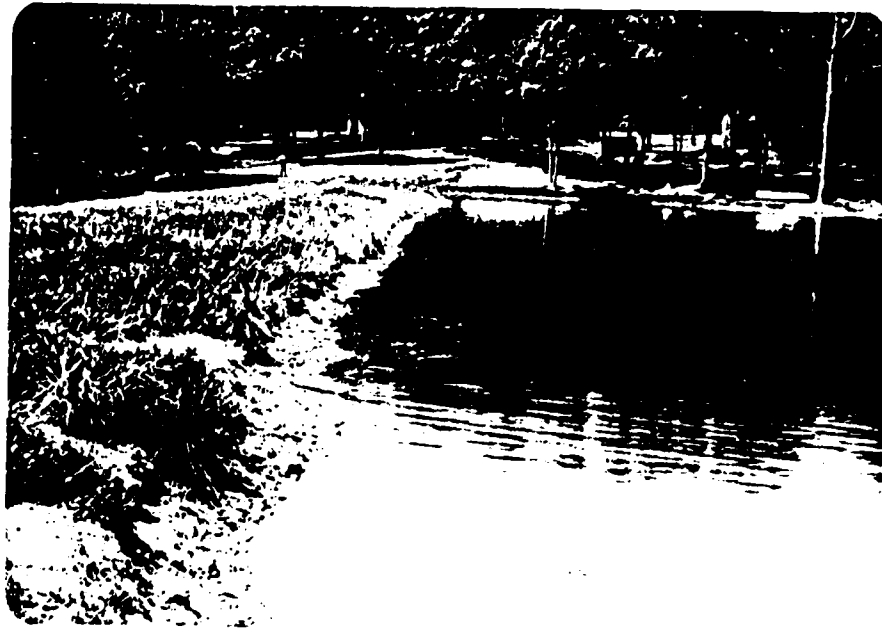
Photo 1

The upstream slope has no riprap protection and has consequently undergone minor erosion from wave action. Exposed material is a clayey silt. Small shrinkage cracks are visible on the top section of the slope. No depressions or bulges were apparent. No evidence of rodent activity was observed on the embankment slope.

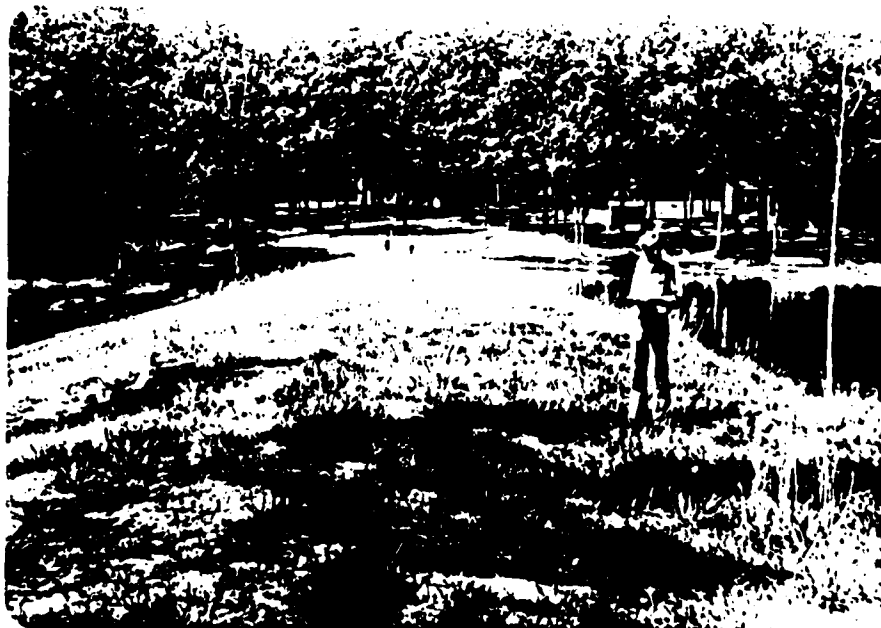
Photo 2

The dam crest was protected against surface erosion by an adequate grass cover. Small shrinkage cracks were visible on the surface. No significant deviations in horizontal or vertical alignment were apparent. A 1-inch wide settlement crack was observed along the contact of the crest with the left abutment. There was no evidence of the dam ever being overtopped.
